# ADVANCED DETECTION SYSTEMS

## The Need for Metal Detection

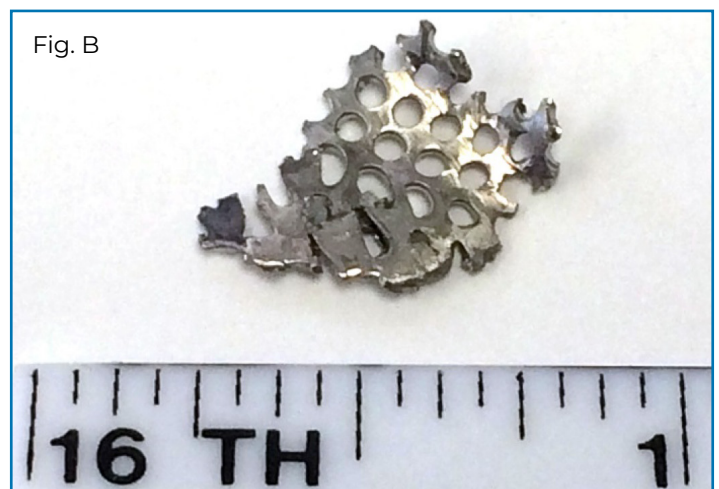
This is a piece of stainless steel extruding screen, used in the production of cheese. (Fig. B) This particular piece of

steel was removed from a customer's product during the setup of a new metal detector. The screen fragmented as a result of the cheese being too cold and pushed too hard through the extruder, resulting in the fracturing of the screen at one of the mounting points. Fortunately, the ProScan Max II metal detector was able to detect this piece without difficulty, the screen was removed and the pieces reassembled like a jigsaw puzzle and accounted for. The producer destroyed the product that contained the metal, and revised their production process to prevent this from happening in the future.

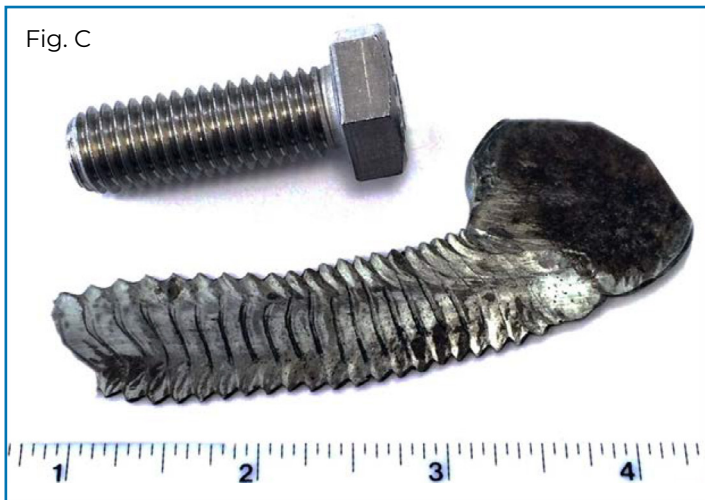
Fig. C

This is what's left of a 3-inch steel bolt that made its way through a roller mill (Fig. C). Unfortunately, the customer didn't use metal detection until after this bolt damaged the mill and caused thousands of dollars in damage. After repairs, loss of production time, and man hours to repair the equipment, the damages from this incident exceeded the cost of a new metal detector!
