ADVANCED DETECTION SYSTEMS

The Need for Metal Detection

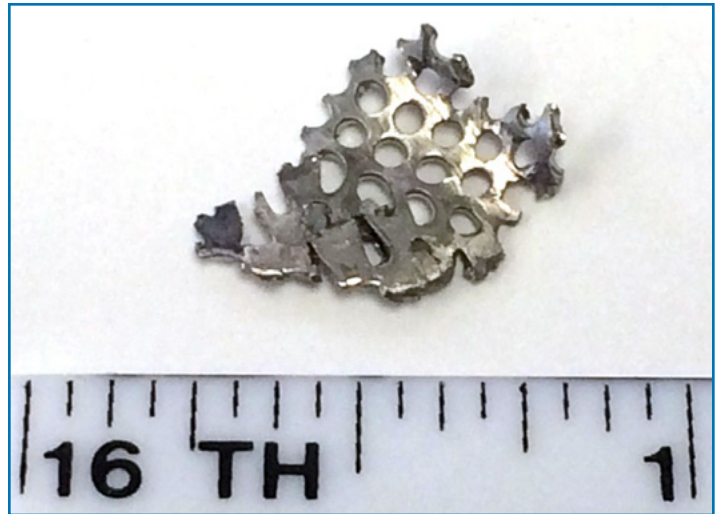
This is a piece of stainless steel extruding screen, used in the production of cheese. This particular piece of steel was removed from a customer's product during the setup of a new metal detector. The screen fragmented as a result of the cheese being too cold and pushed too hard through the extruder, resulting in the fracturing of the screen at one of the mounting points. Fortunately, the ProScan Max II metal detector was able to detect this piece without difficulty, the screen was removed and the pieces reassembled like a jigsaw puzzle and accounted for. The producer destroyed the product that contained the metal, and revised their production process to prevent this from happening in the future.

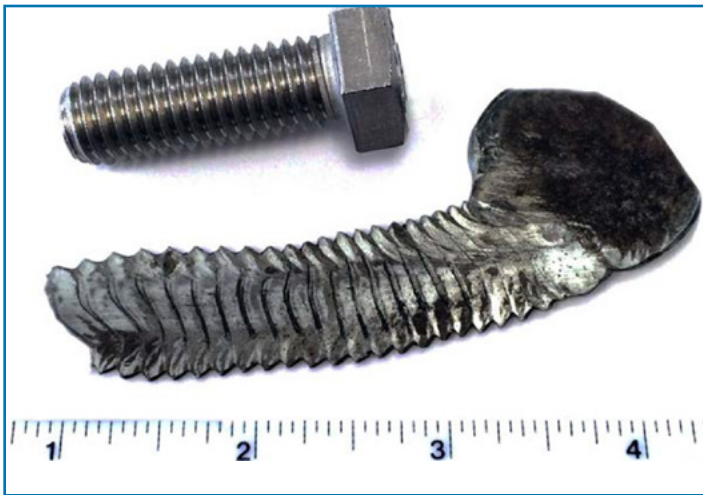
This is what's left of a 3-inch steel bolt that made its way through a roller mill. Unfortunately, the customer didn't use metal detection until after this bolt damaged the mill and caused thousands of dollars in damage. After repairs, loss of production time, and man hours to repair the equipment, the damages from this incident exceeded the cost of a new metal detector!
