# ADVANCED DETECTION SYSTEMS

## The Need for Metal Detection

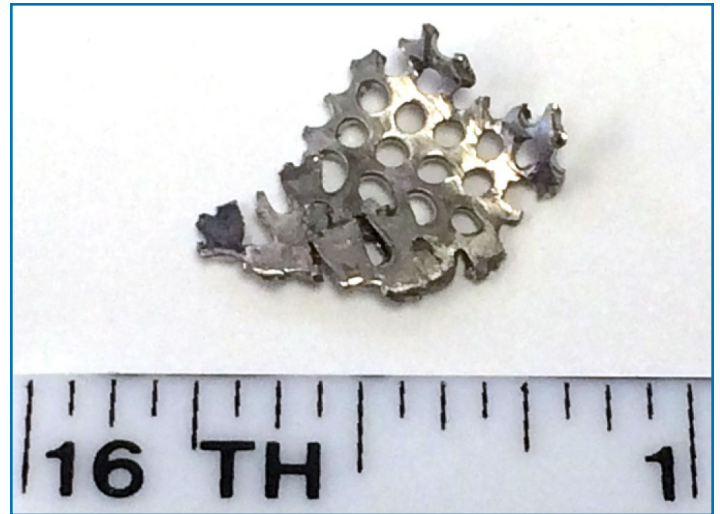
**This is a piece of stainless steel extruding screen, used in the production of cheese.** This particular piece of steel was removed from a customer's product during the setup of a new metal detector. The screen fragmented as a result of the cheese being too cold and pushed too hard through the extruder, resulting in the fracturing of the screen at one of the mounting points. Fortunately, the ProScan Max II metal detector was able to detect this piece without difficulty, the screen was removed and the pieces reassembled like a jigsaw puzzle and accounted for. The producer destroyed the product that contained the metal, and revised their production process to prevent this from happening in the future.

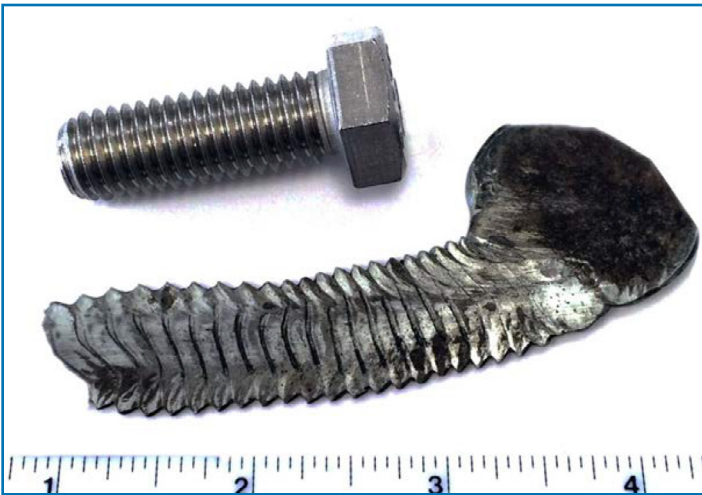
**This is what's left of a 3-inch steel bolt that made its way through a roller mill.** Unfortunately, the customer didn't use metal detection until after this bolt damaged the mill and caused thousands of dollars in damage. After repairs, loss of production time, and man hours to repair the equipment, the damages from this incident exceeded the cost of a new metal detector!
